## Conceptual Design Memorandum

### Zandale Park Stream Bank Protection Project

Prepared for  
Lansdowne Neighborhood Association  
June, 2012

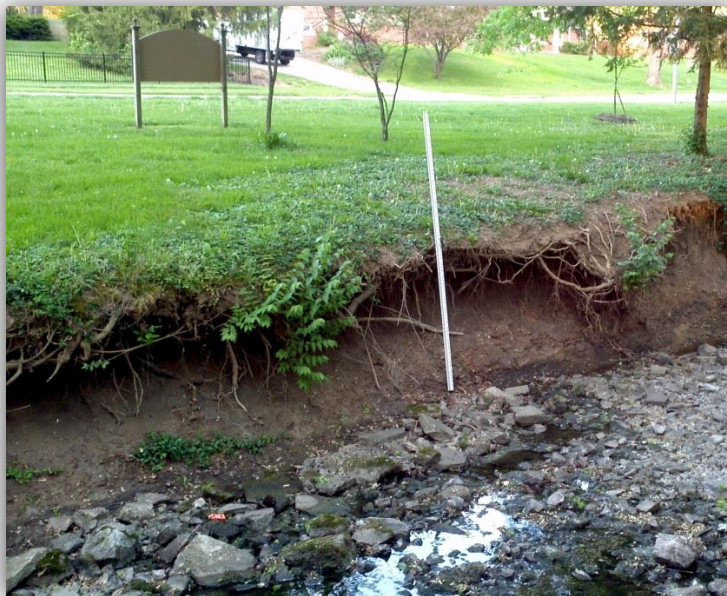
Regarding the first point, bank instability throughout the park is an unsightly blemish in an otherwise well-kept park. The bank erosion is also resulting in active loss of notable riparian trees (Figure 1).

**(1a) Active Bank Failure Downstream of the Pedestrian Bridge  
adjacent to Zandale Park Entrance Sign**

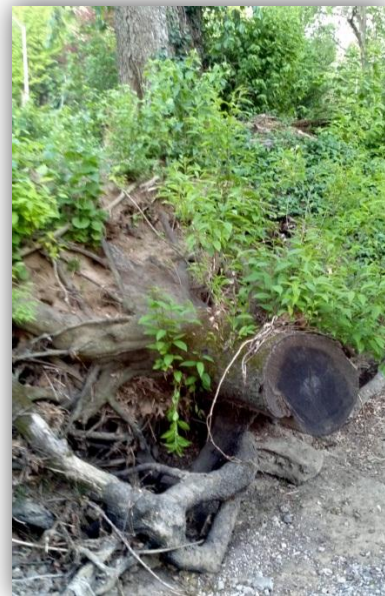
**(1b) Stump of 18-inch Tree Recently  
Lost to Bank Erosion**

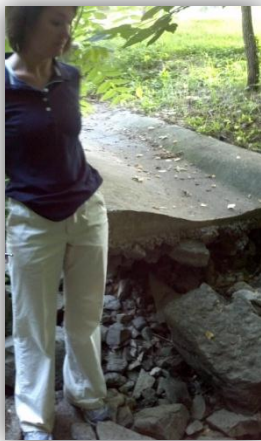
**(2a) Stormwater Outfall  
Undermined by Channel  
Downcutting**

In addition to the pedestrian bridge, the pier supporting the sanitary sewer crossing (near Site A) and several stormwater outfalls should also be reinforced to minimize additional scour and undermining by the channel. This can be achieved with a single wing deflector at the sanitary sewer crossing. Approximately 3 cubic yards of rock reinforcement should be added at the sanitary sewer crossing.

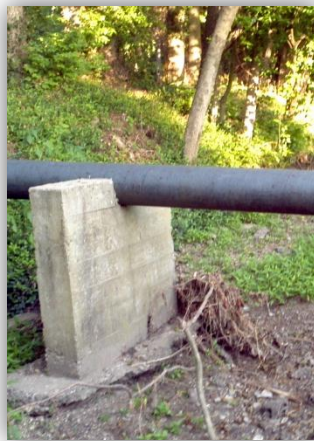
**(2b) Sanitary Sewer Crossing  
– Concrete Pier Support  
Undergoing Scour**

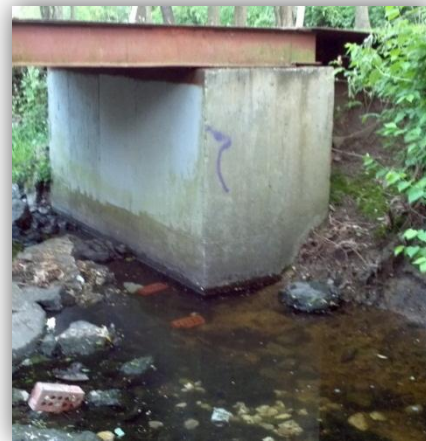
**(2c) Pier Scour and Flanking of  
Pedestrian Bridge**

Additional protection will be necessary for the piers supporting the pedestrian bridge, several stormwater outfalls, and the piers supporting the sanitary sewer crossing. A double wing deflector installed beneath the pedestrian bridge around the pier supports should prevent additional scour and flanking in this location. The two wing deflectors, which are constructed from large rocks, will each extend into the channel about a fourth to a third of the way and reduce the baseflow channel width by at least one-half. During the first year after construction the deflectors should be inspected and maintained after every large storm event, and then they should be inspected annually following the first year. If the inspector observes any changes (movement or loss of rock) the wing deflector should be repaired immediately (Center for Watershed Protection, 2004).

The wing deflectors for the pedestrian bridge in Zandale Park would require approximately 26 cubic yards of rock. Figure 11 presents an example (plan view and cross section) of a double wing deflector and Figure 12 presents several photos of double wing deflectors.

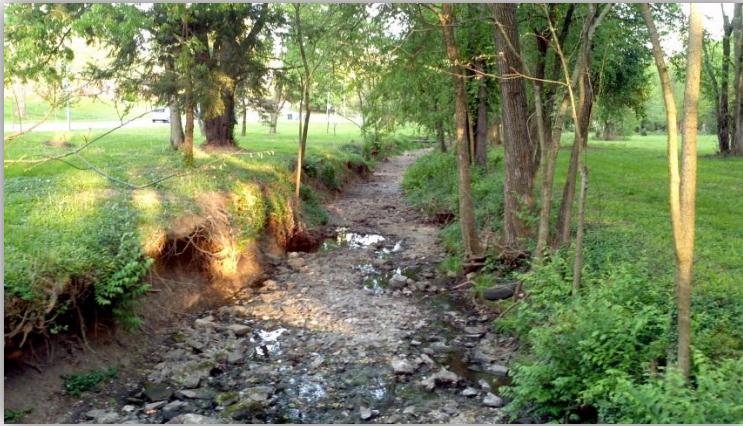
The Zandale Park Creek is undergoing a very unstable period of channel evolution that ranges between Stage 3 and Stage 4 in the schematic shown in Figure 3 below. There are portions of the channel that are actively widening from the current width of ~23 feet. Banks are near vertical and range 4- to 6-feet high. Other portions have already undergone widening (~26-feet wide) and are beginning to develop vegetated point bars and benches. The goal of the project would be to artificially accelerate the evolution process, such that the stream re-attains a stable, equilibrium form and minimizes additional periods of bank erosion and failure. Figure 3 presents the channel evolution process and two examples of different stages on the unnamed tributary to West Hickman Creek. Figure 4 illustrates how stream instability can migrate up and downstream in relation to a hardpoint such bedrock. This explains the reason for the headcutting and increased slope on the upstream portion of the stream within Zandale Park and is further explained in Section 4 *Field Data Collection and Processed Metrics*.

**(3a) Reach Immediately Downstream of Pedestrian Bridge (~23' Wide) Undergoing Dencutting and Widening (Stage 3 of Channel Evolution) Evident by Coarse Bed Material and Active Bank Failure. This is the location of hydrogeomorphic site B (discussed later in this memo).**

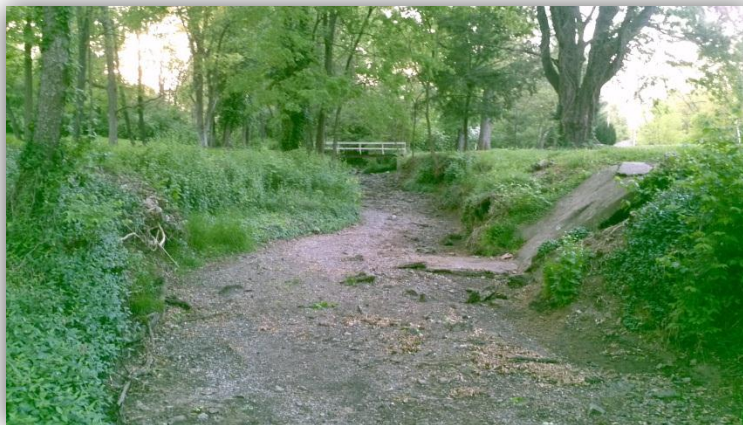
**(3b) Reach Farther Downstream of Pedestrian Bridge (~26' Wide) Undergoing Deposition and Floodplain Reconstruction (Stage 4 of Channel Evolution) Evident by Fine Bed Material and Vegetated Point Bars, Benches, and Banks. This is close to the location of hydrogeomorphic site A (discussed later in this memo).**

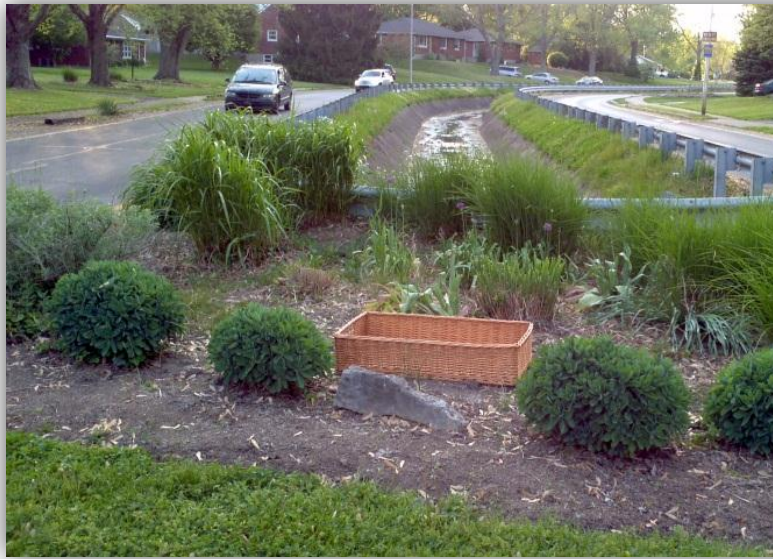
**(5a) View of Concrete-lined Channel Immediately Upstream of Zandale Park**

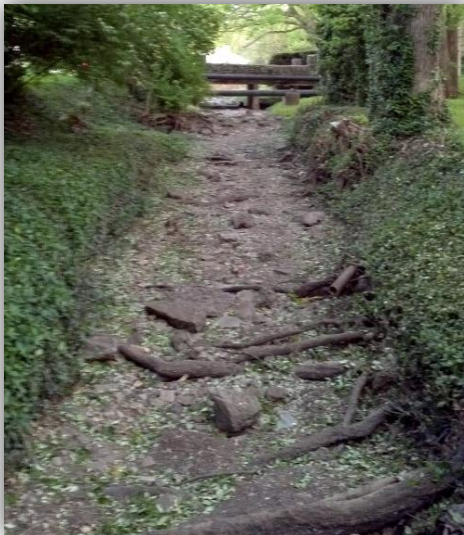
**(5b) View of Relatively Stable Reach Immediately Upstream of the Culvert Crossing with Lansdowne Estates (Stage 5 of Channel Evolution) Evident by Low, Vegetated Banks and A Channel Bed Reinforced with Large Tree Roots and Woody Debris**

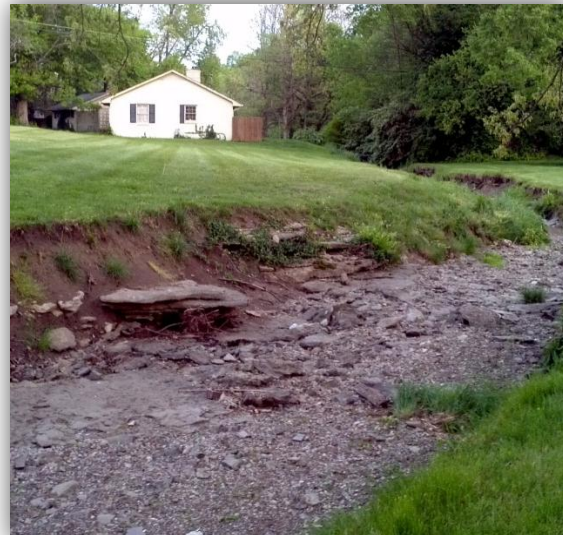
**(5c) Looking Downstream from the Culvert Crossing at Lansdowne Estates—Note the Limestone Bedrock on the Channel Bed and Protruding from the Left Bank**
