## Conceptual Design Memorandum

### Zandale Park Stream Bank Protection Project

Prepared for  
Lansdowne Neighborhood Association  
June, 2012

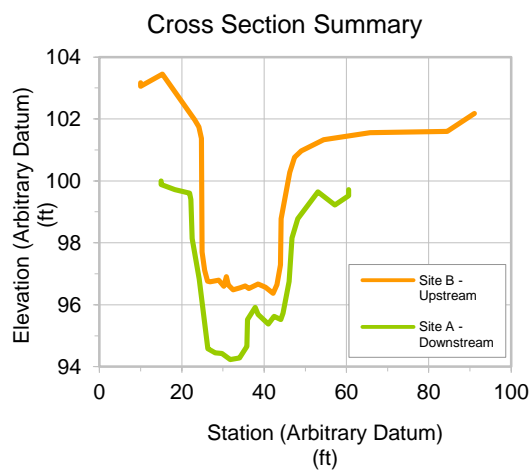
Figure 7 – Superimposed Cross Sections

Superimposed cross sections, pebble counts, and the profile are provided in Figures 7 – 9, respectively. Profile slopes over the reaches ranged from 0.2% on the downstream portion of the stream segment to 1.1% on the upstream portion of the segment, while  $d_{50}$  and  $d_{84}$  was around 46 mm and 120 mm (respectively) for Site B and 11 mm and 26 mm (respectively) for Site A. As evident in Figure 7, the bed material gradation at Site A is much finer than Site B because this site is experiencing aggradation and the finer particles have migrated downstream to this site. As previously illustrated in Figure 3(b), this portion of the stream is in Stage 4 of the Channel Evolution Process and is experiencing deposition and floodplain reconstruction. The terrace shown in the Cross Section Summary (Figure 7) around station 35-45 illustrates the floodplain reconstruction. Key metrics are summarized in Table 2. It should be noted that drainage area delineations and area estimates are approximate and were determined with the Kentucky USGS Stream Stats software.

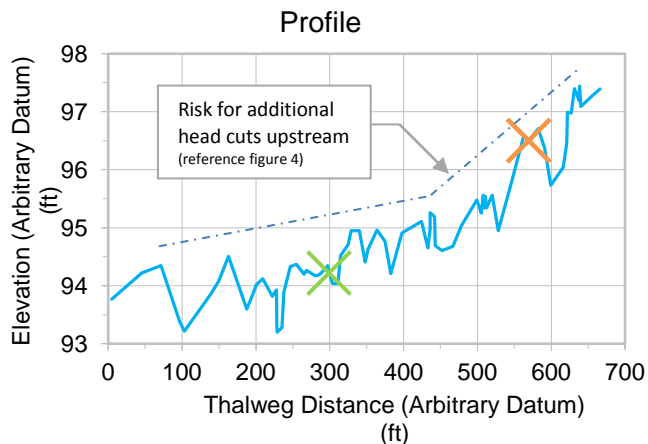
Figure 9 – Profile

Note: Cross section locations of sites A and B are indicated by the green and orange 'X', respectively.
